"How are hotspots identified at the railway, and how should the IM cope with the variable levels of risks?"

UIC, Paris, 25.03.2019

Master  
thesis 2018,  
HSE, NTNU  
& Bane NOR

«Unwanted occurrences at the Norwegian railway where third persons are hit by Train».

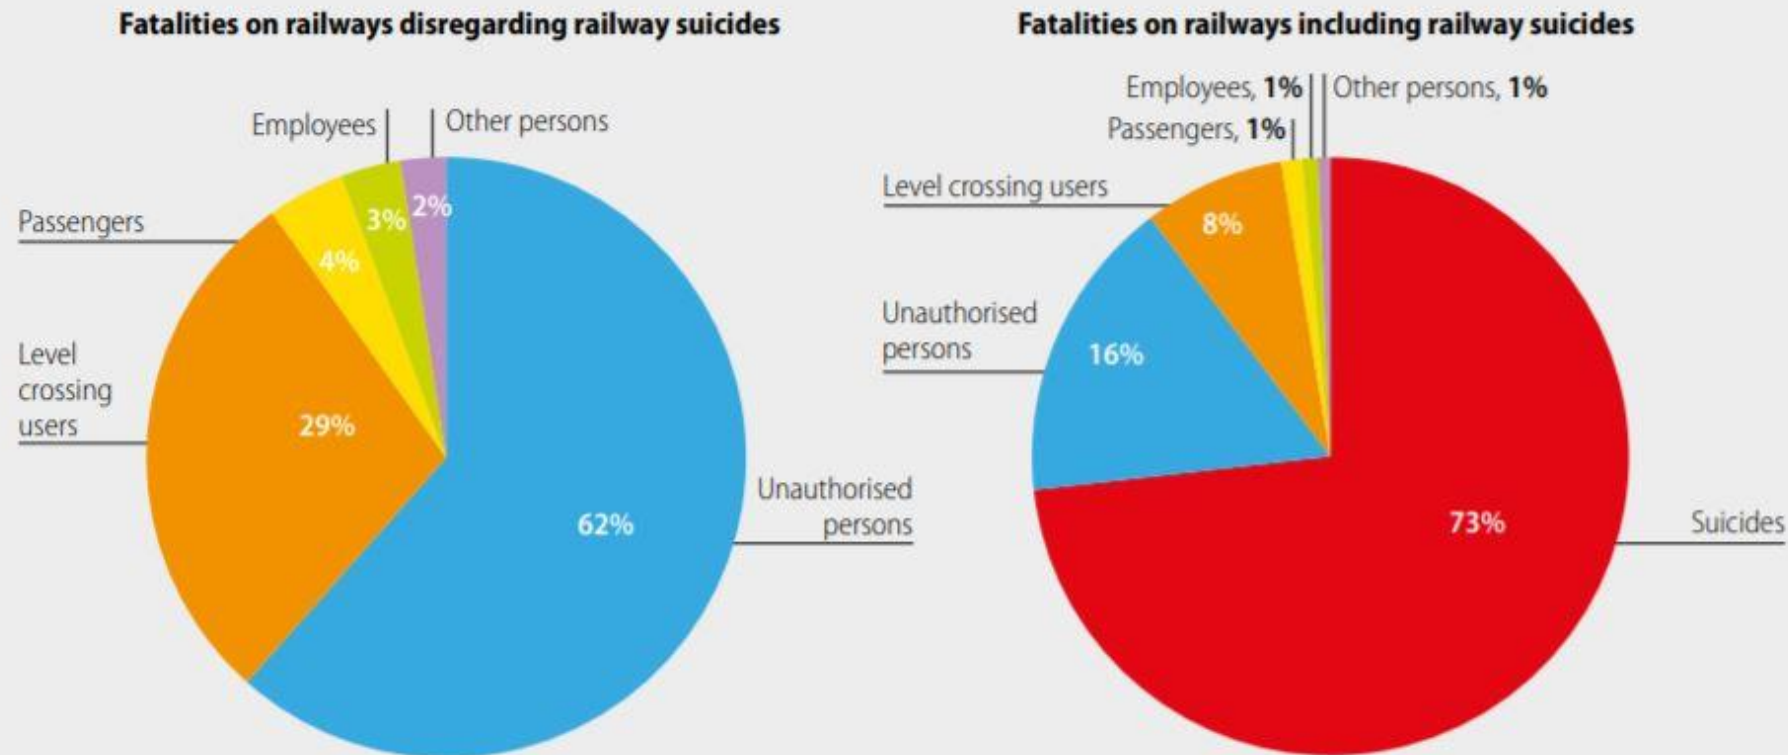
# Approx. ¾ of fatalities are suicides

- Third persons represent more than 90% of the remaining

**Figure 8:** Relative share of fatalities per victim category among all fatalities with (right) and without (left) suicides, EU 28, 2012-2016

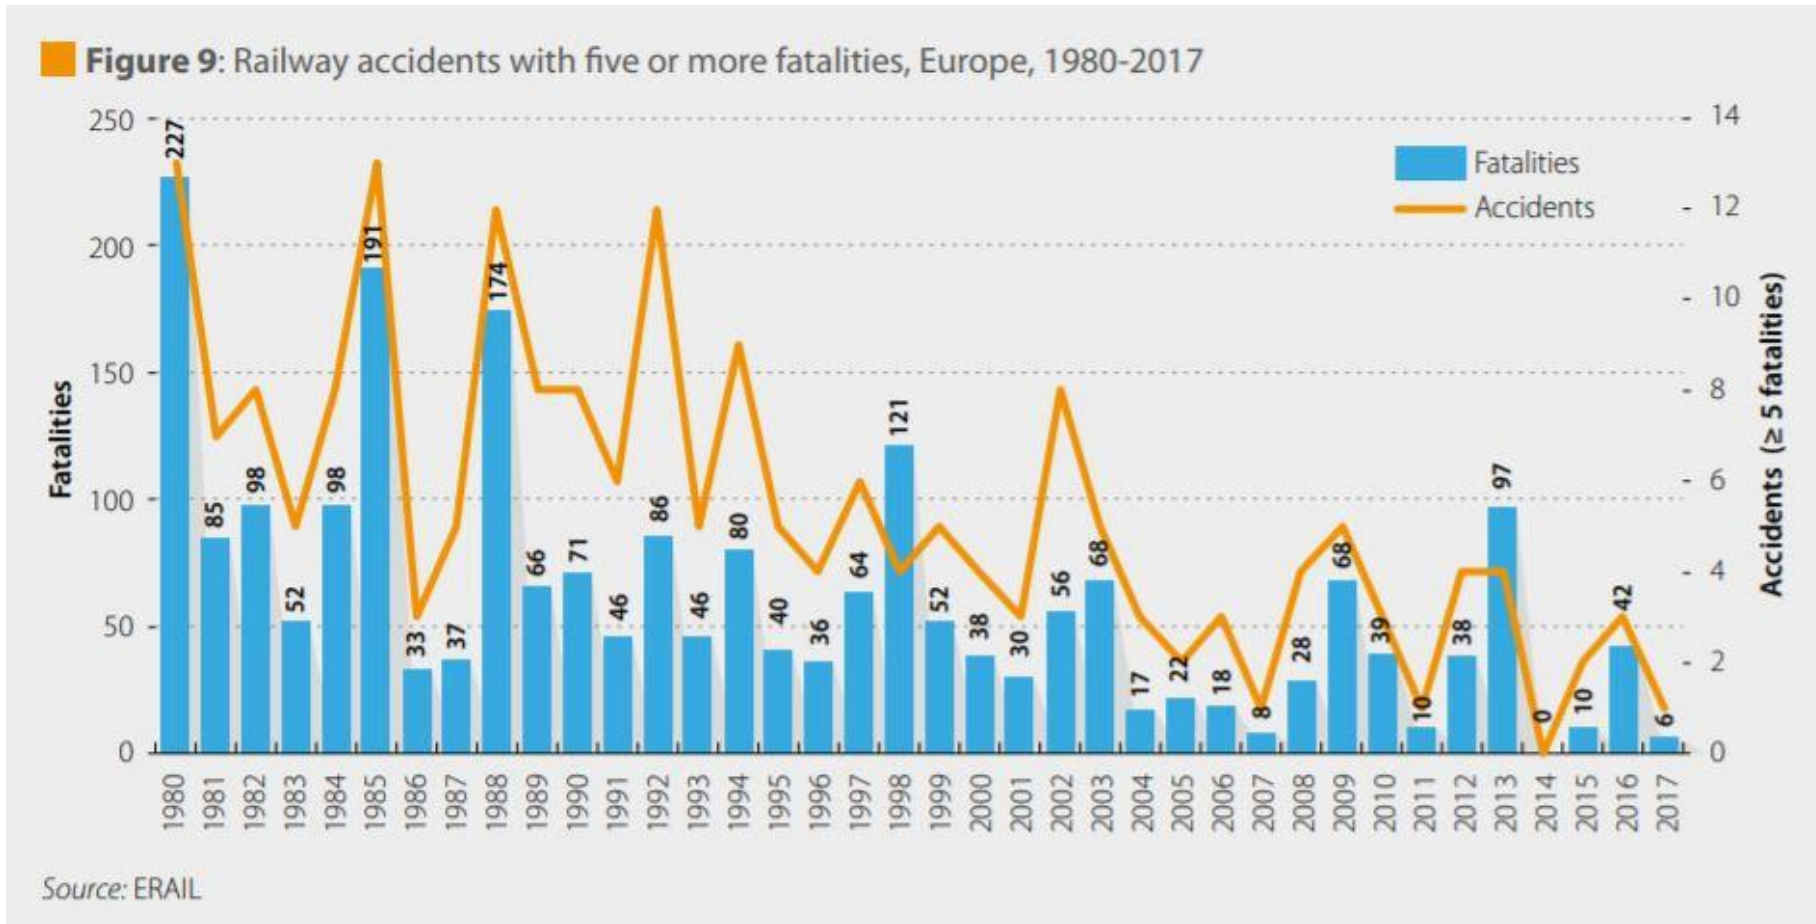
Trend: 1-fatality-accidents constitute for a greater share of the total fatalities

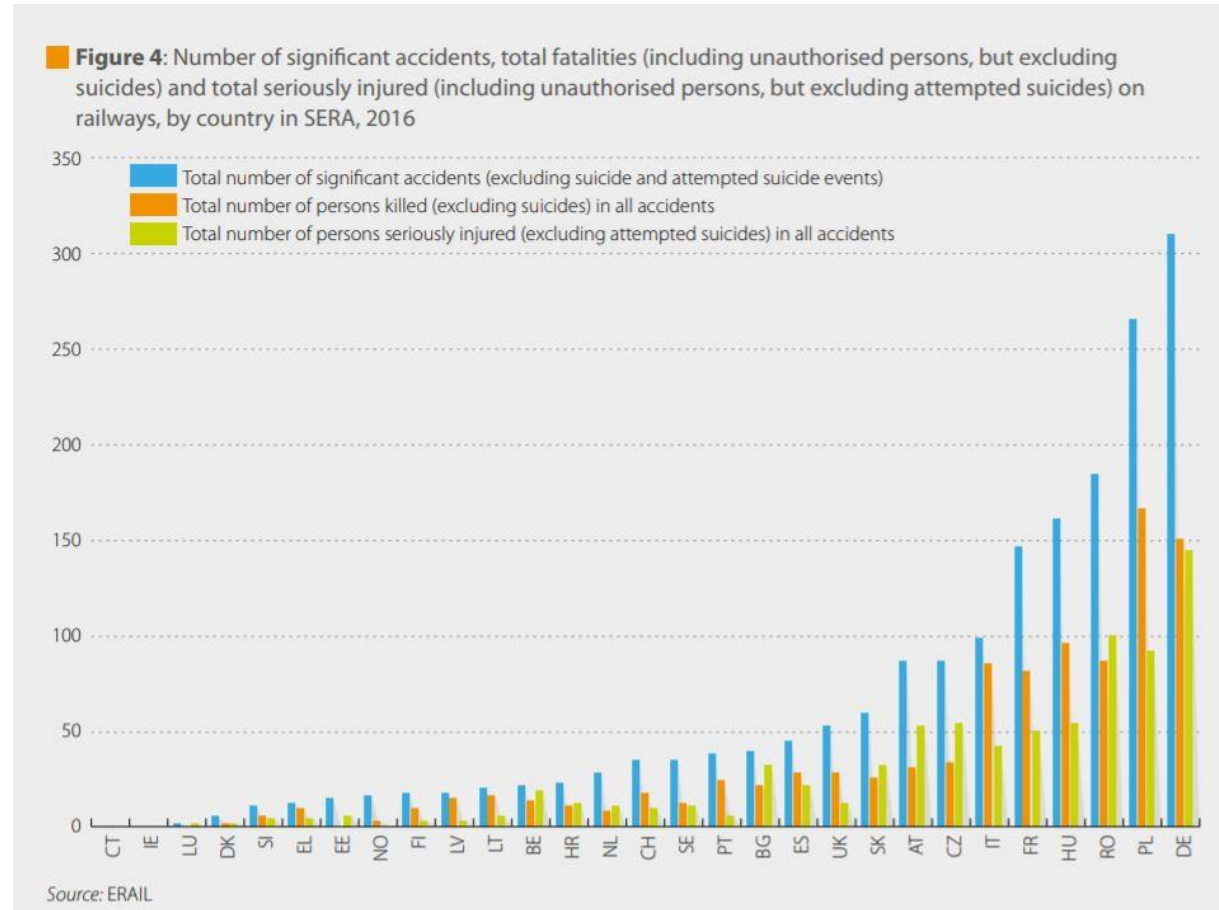
# Norway amongst the European countries with fewest fatalities at the railway

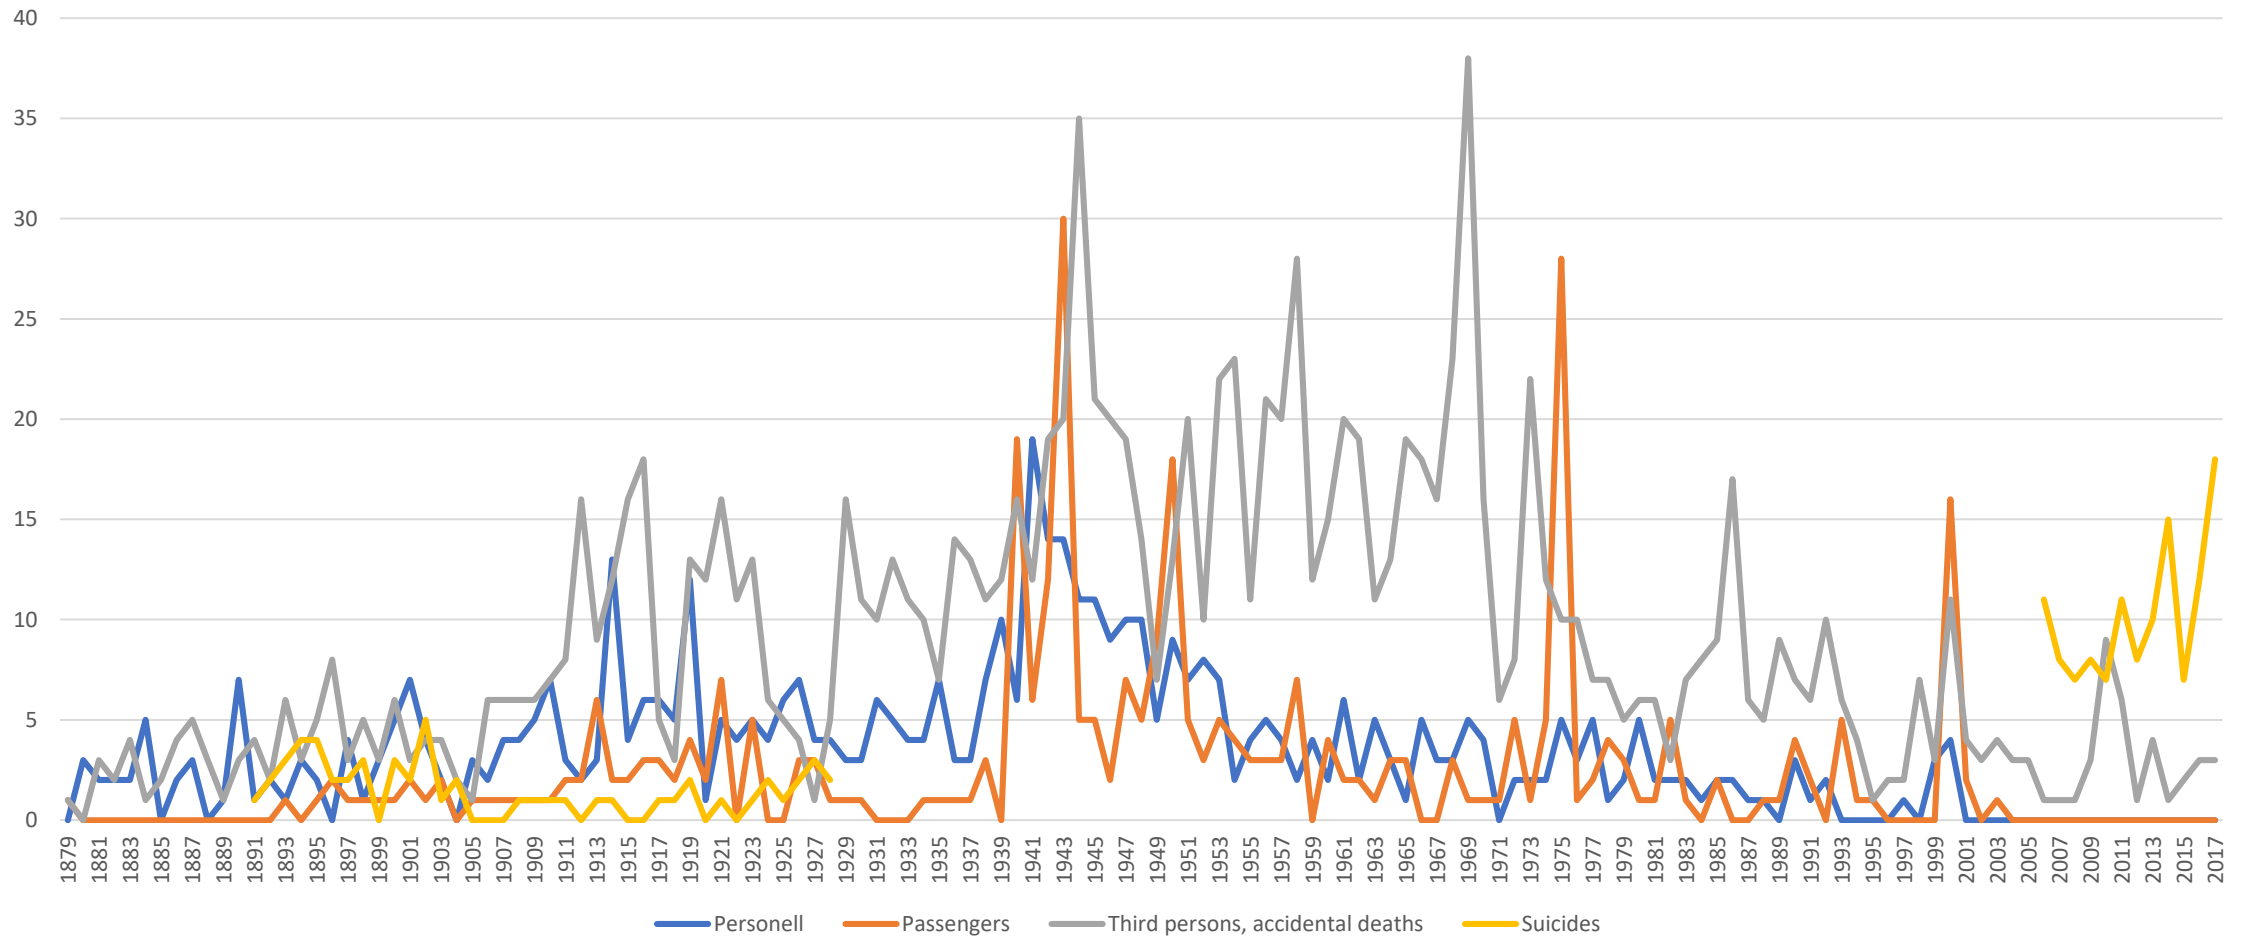
# Historical overview: (Sources; SSB, NSB, JBV, ERAIL)

## Fatalities at the norwegian railway, 1879-2017

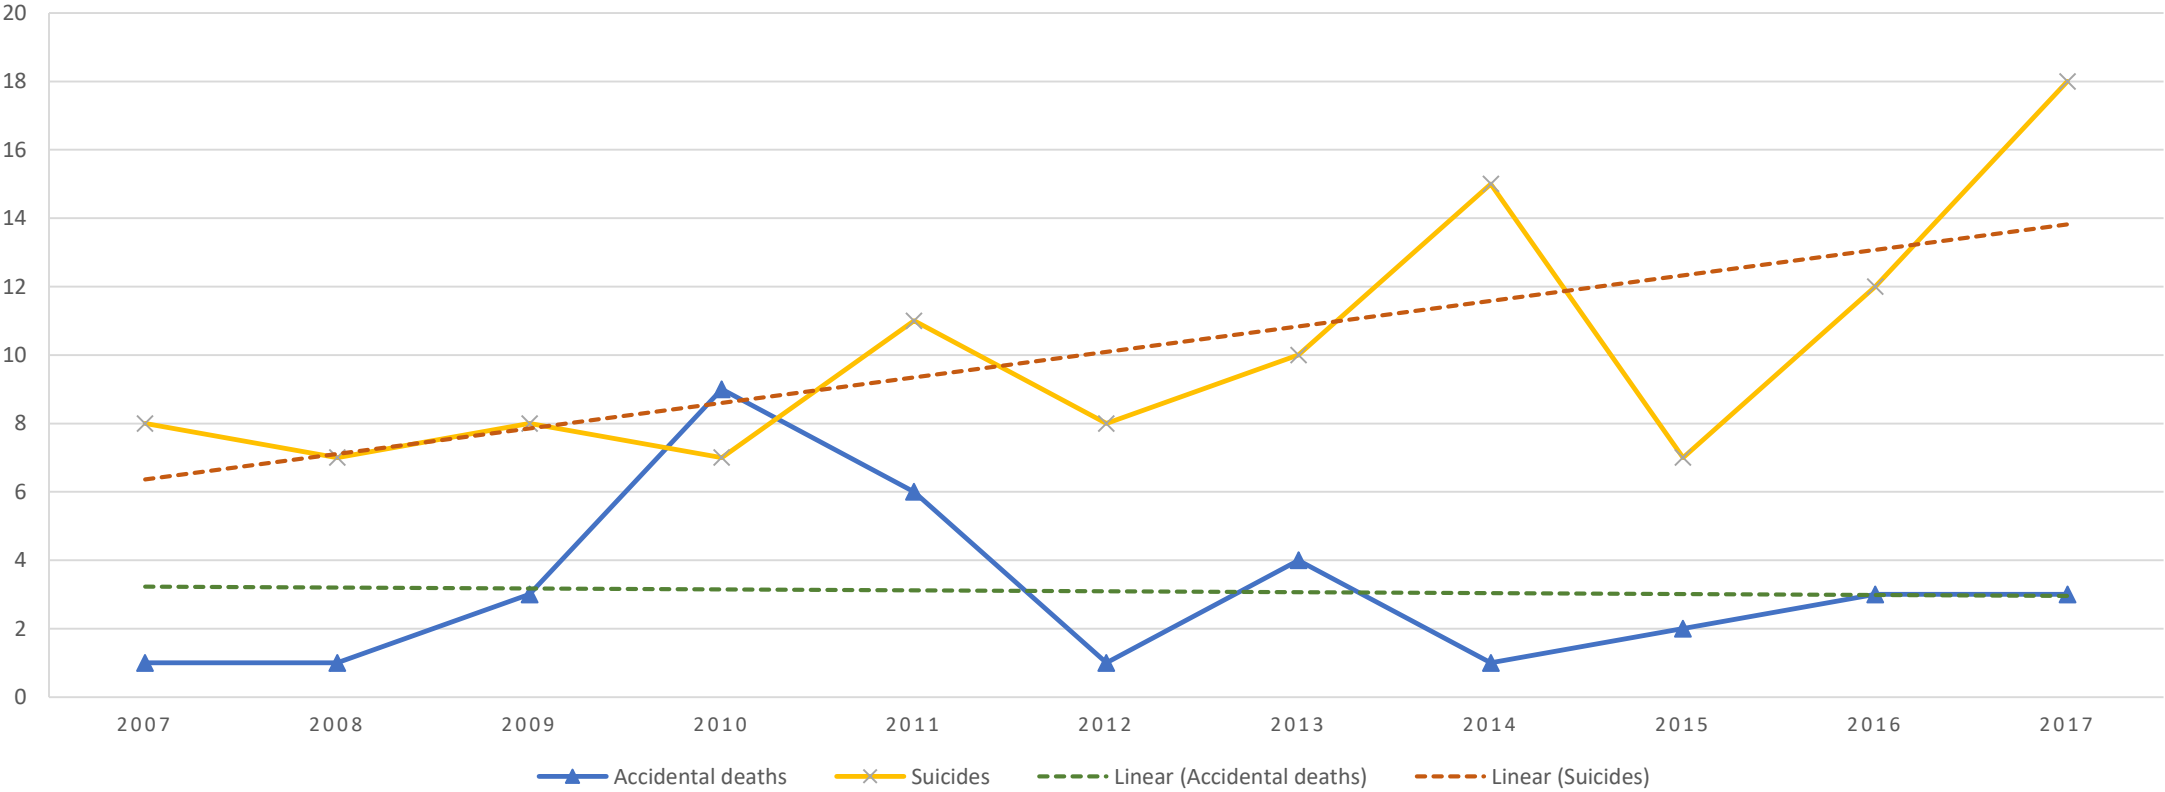
# Trend; increased no. of suicides

## FATALITIES AT THE NORWEGIAN RAILWAY, 2007-2017

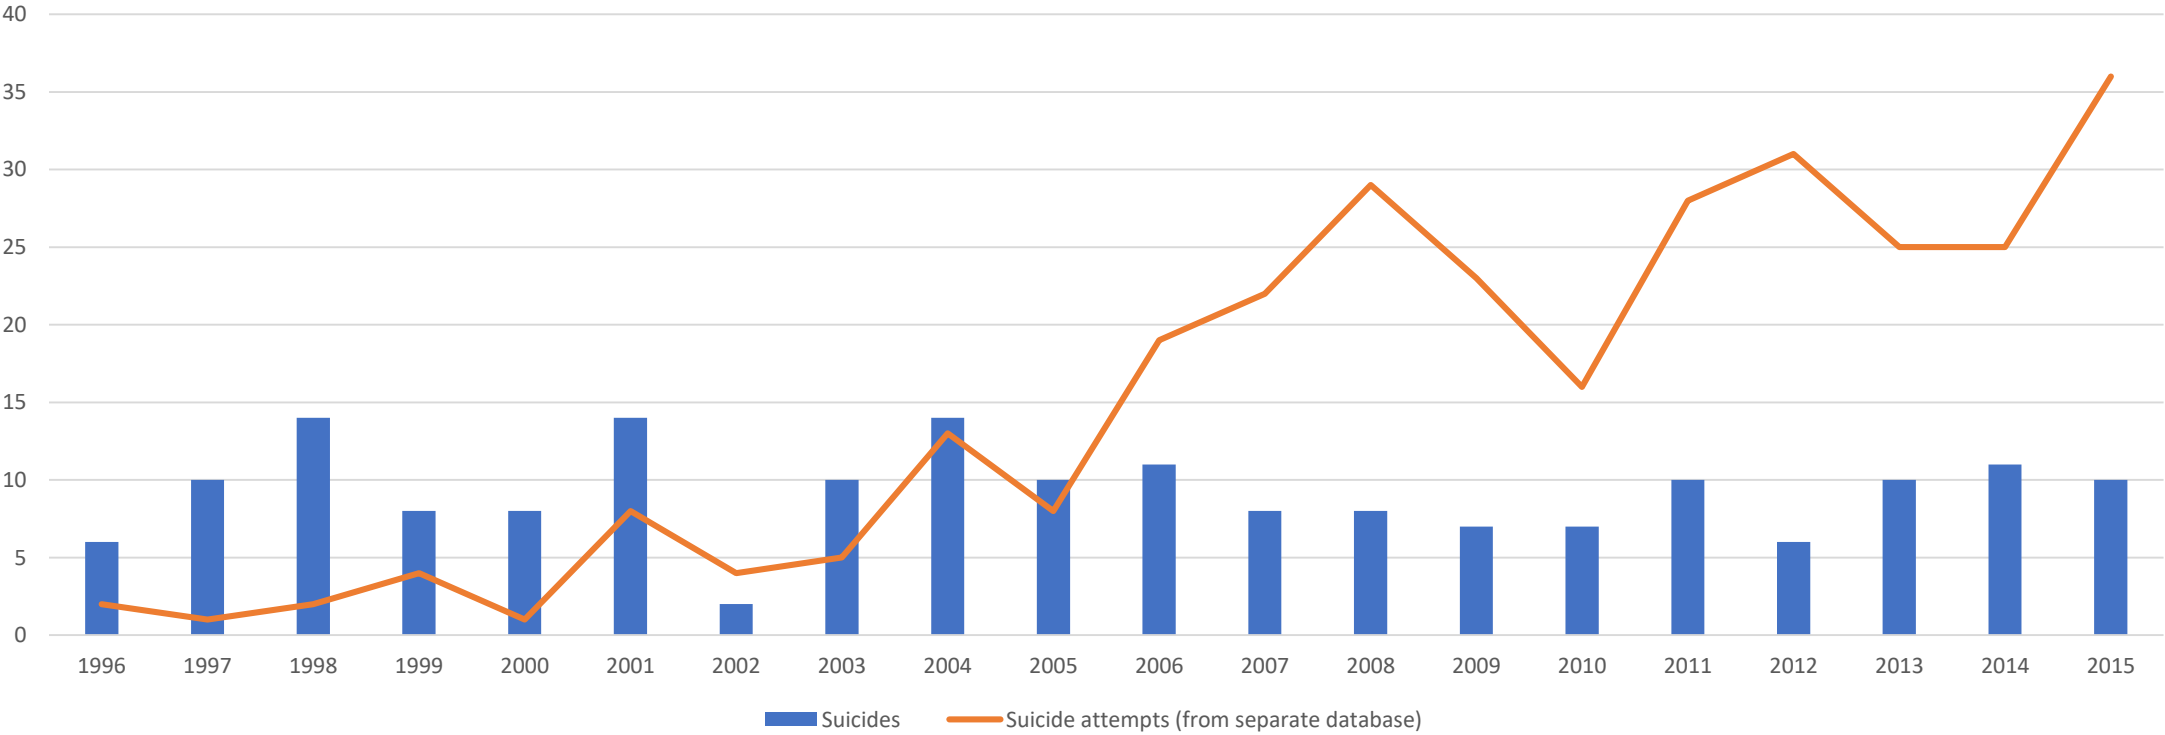
# Are all attempted suicides registered?

No. of registered suicides and attempted at the Norwegian railway  
1996-2015 (Source: JBV (IM))

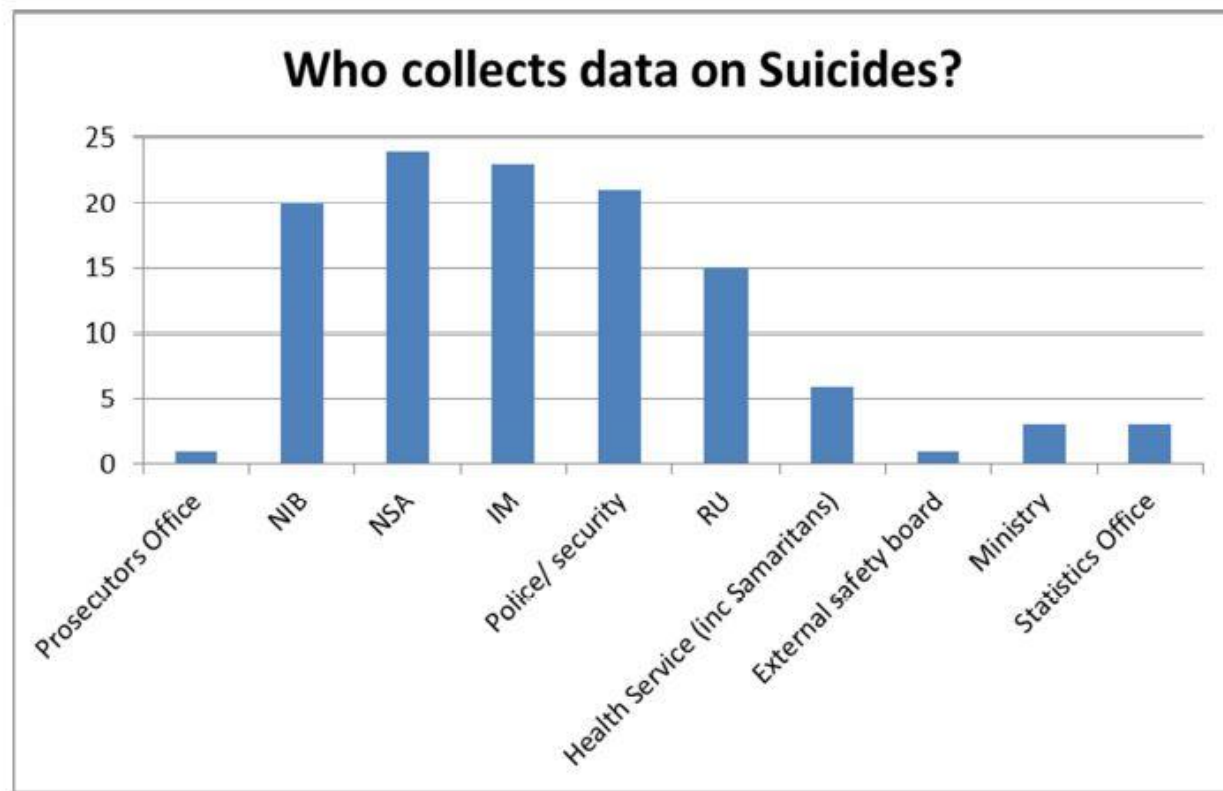
Figure 1 – A Count of the Responses to the Identity of Those Organisations Collecting Data on Suicide on Railway Premises

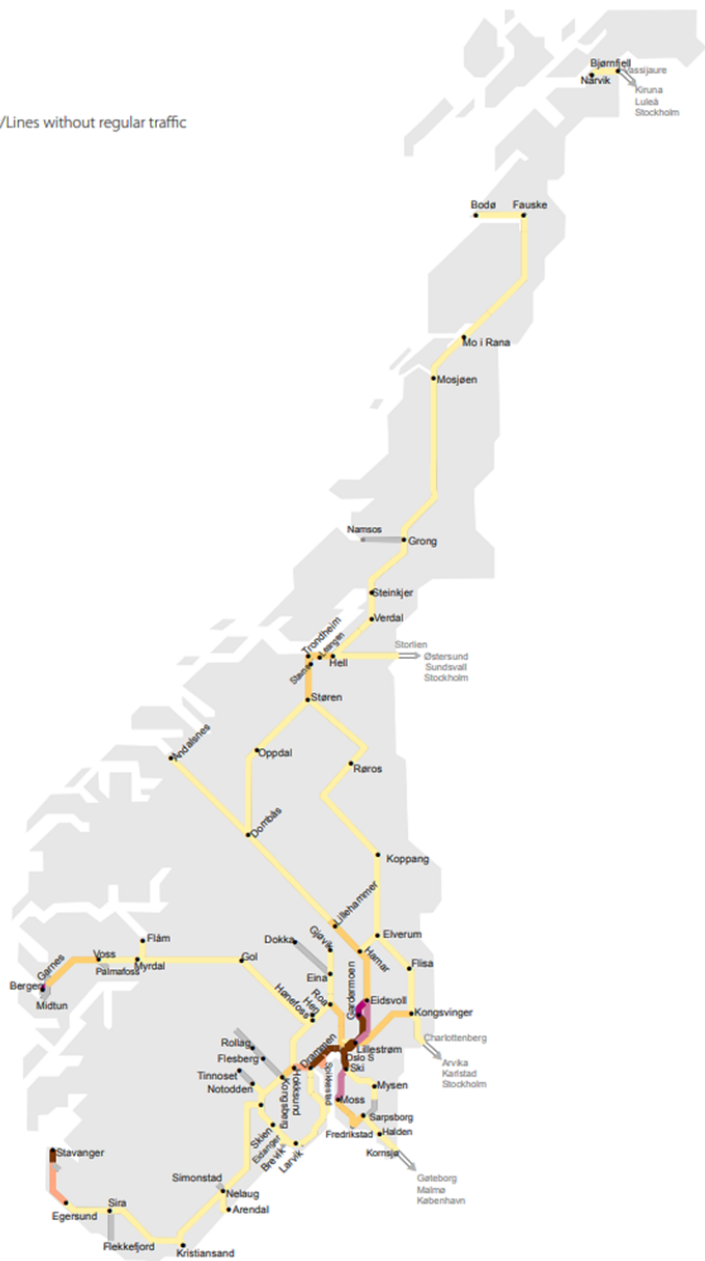
Togmengde (person- og godstog) - antall tog per døgn (sum begge retninger) /  
Number of trains per day (passenger and freight trains, sum both directions)

# Suicides and trespasses seems to correlate with traffic and demographics

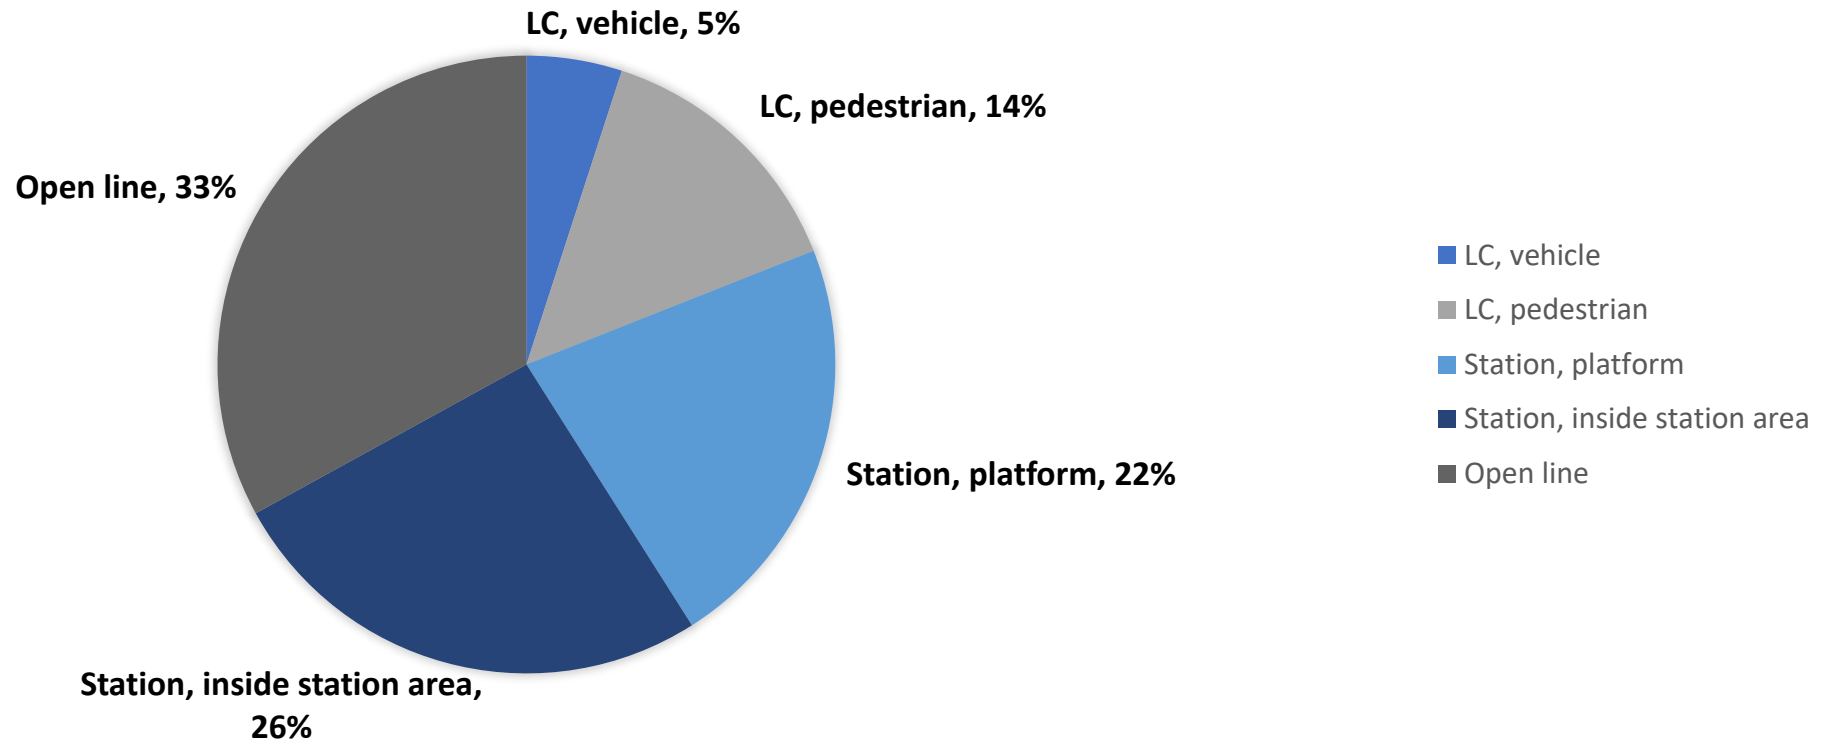
# Distrubution at LCs, stations or open line

## DISTRIBUTION OF DEATHS AT THE NORWEGIAN RAILWAY 2007-2016

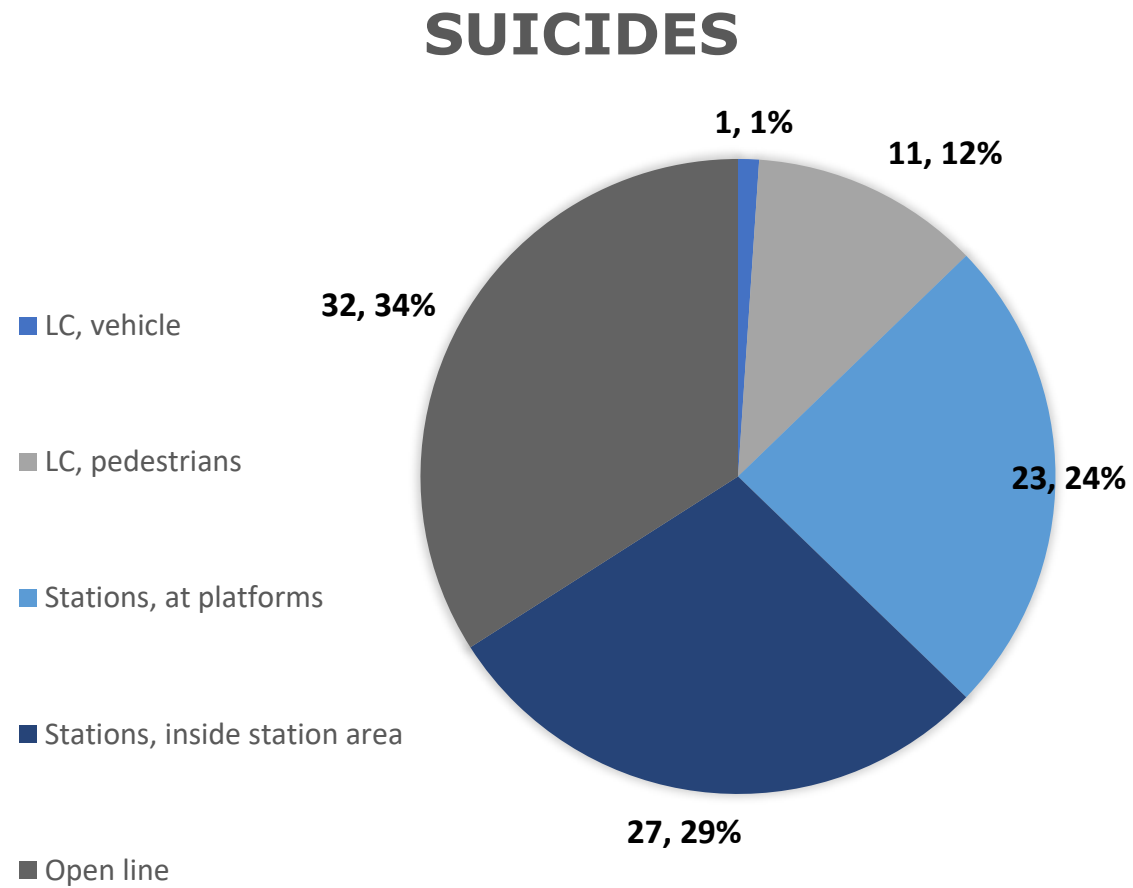
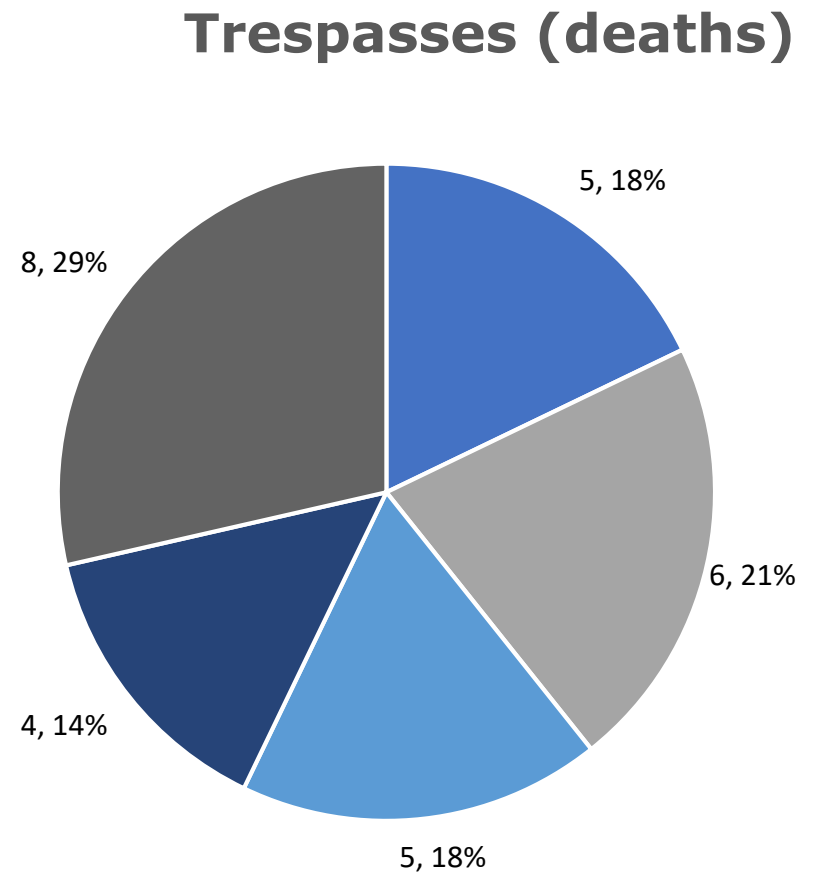
# Different distribution of suicides and other fatalities

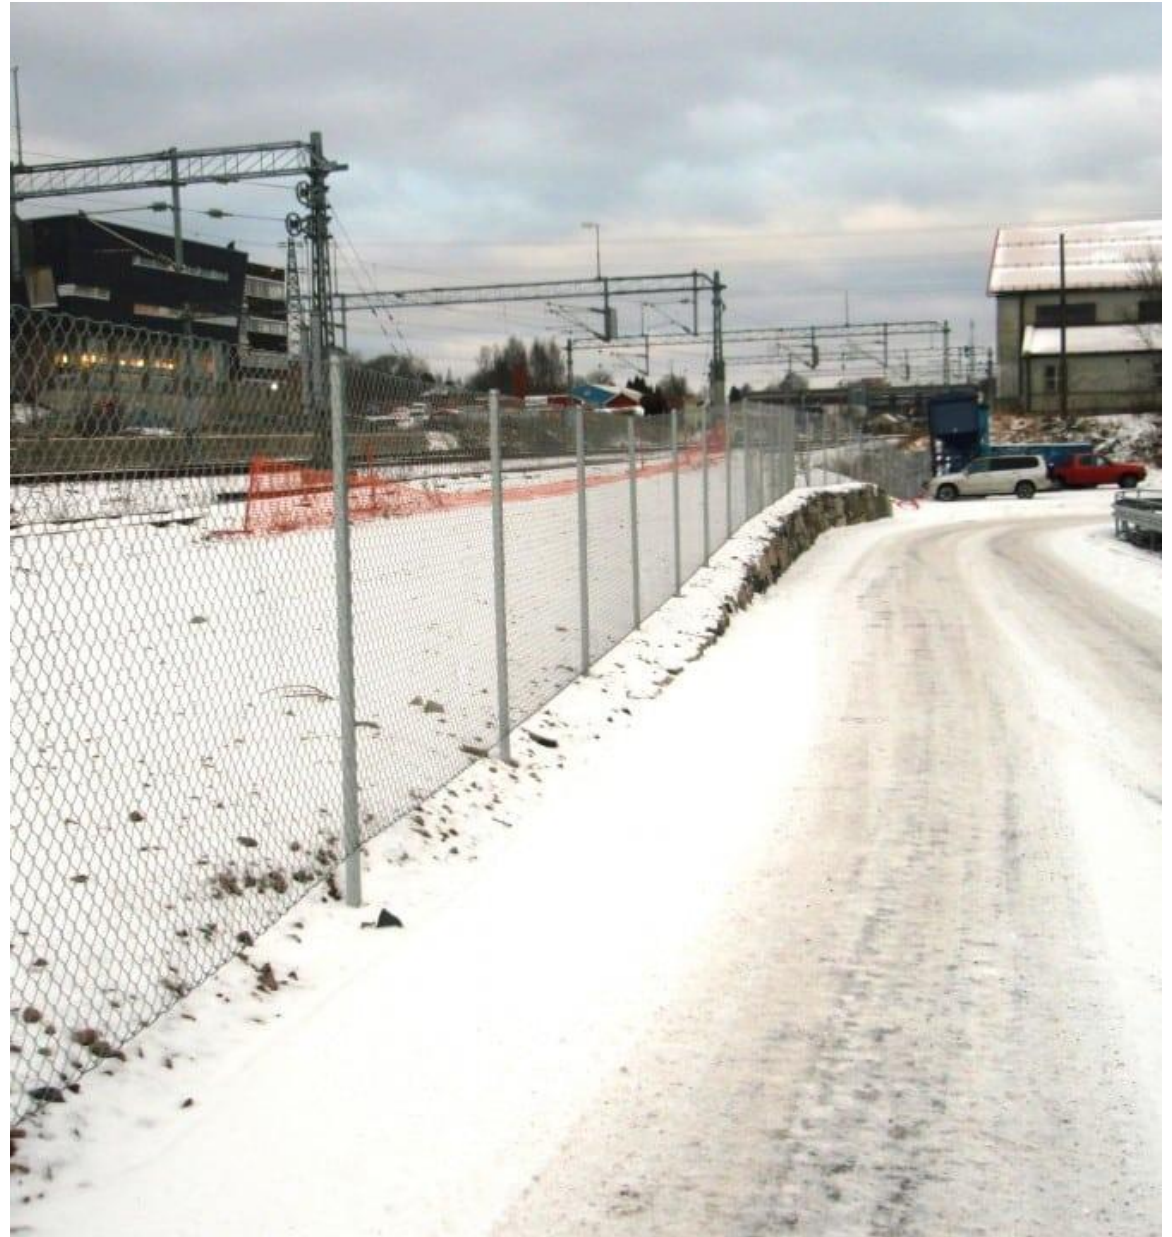
Demand in  
Norway: chain-  
link fences  
(Source;  
Herasnorge.no)

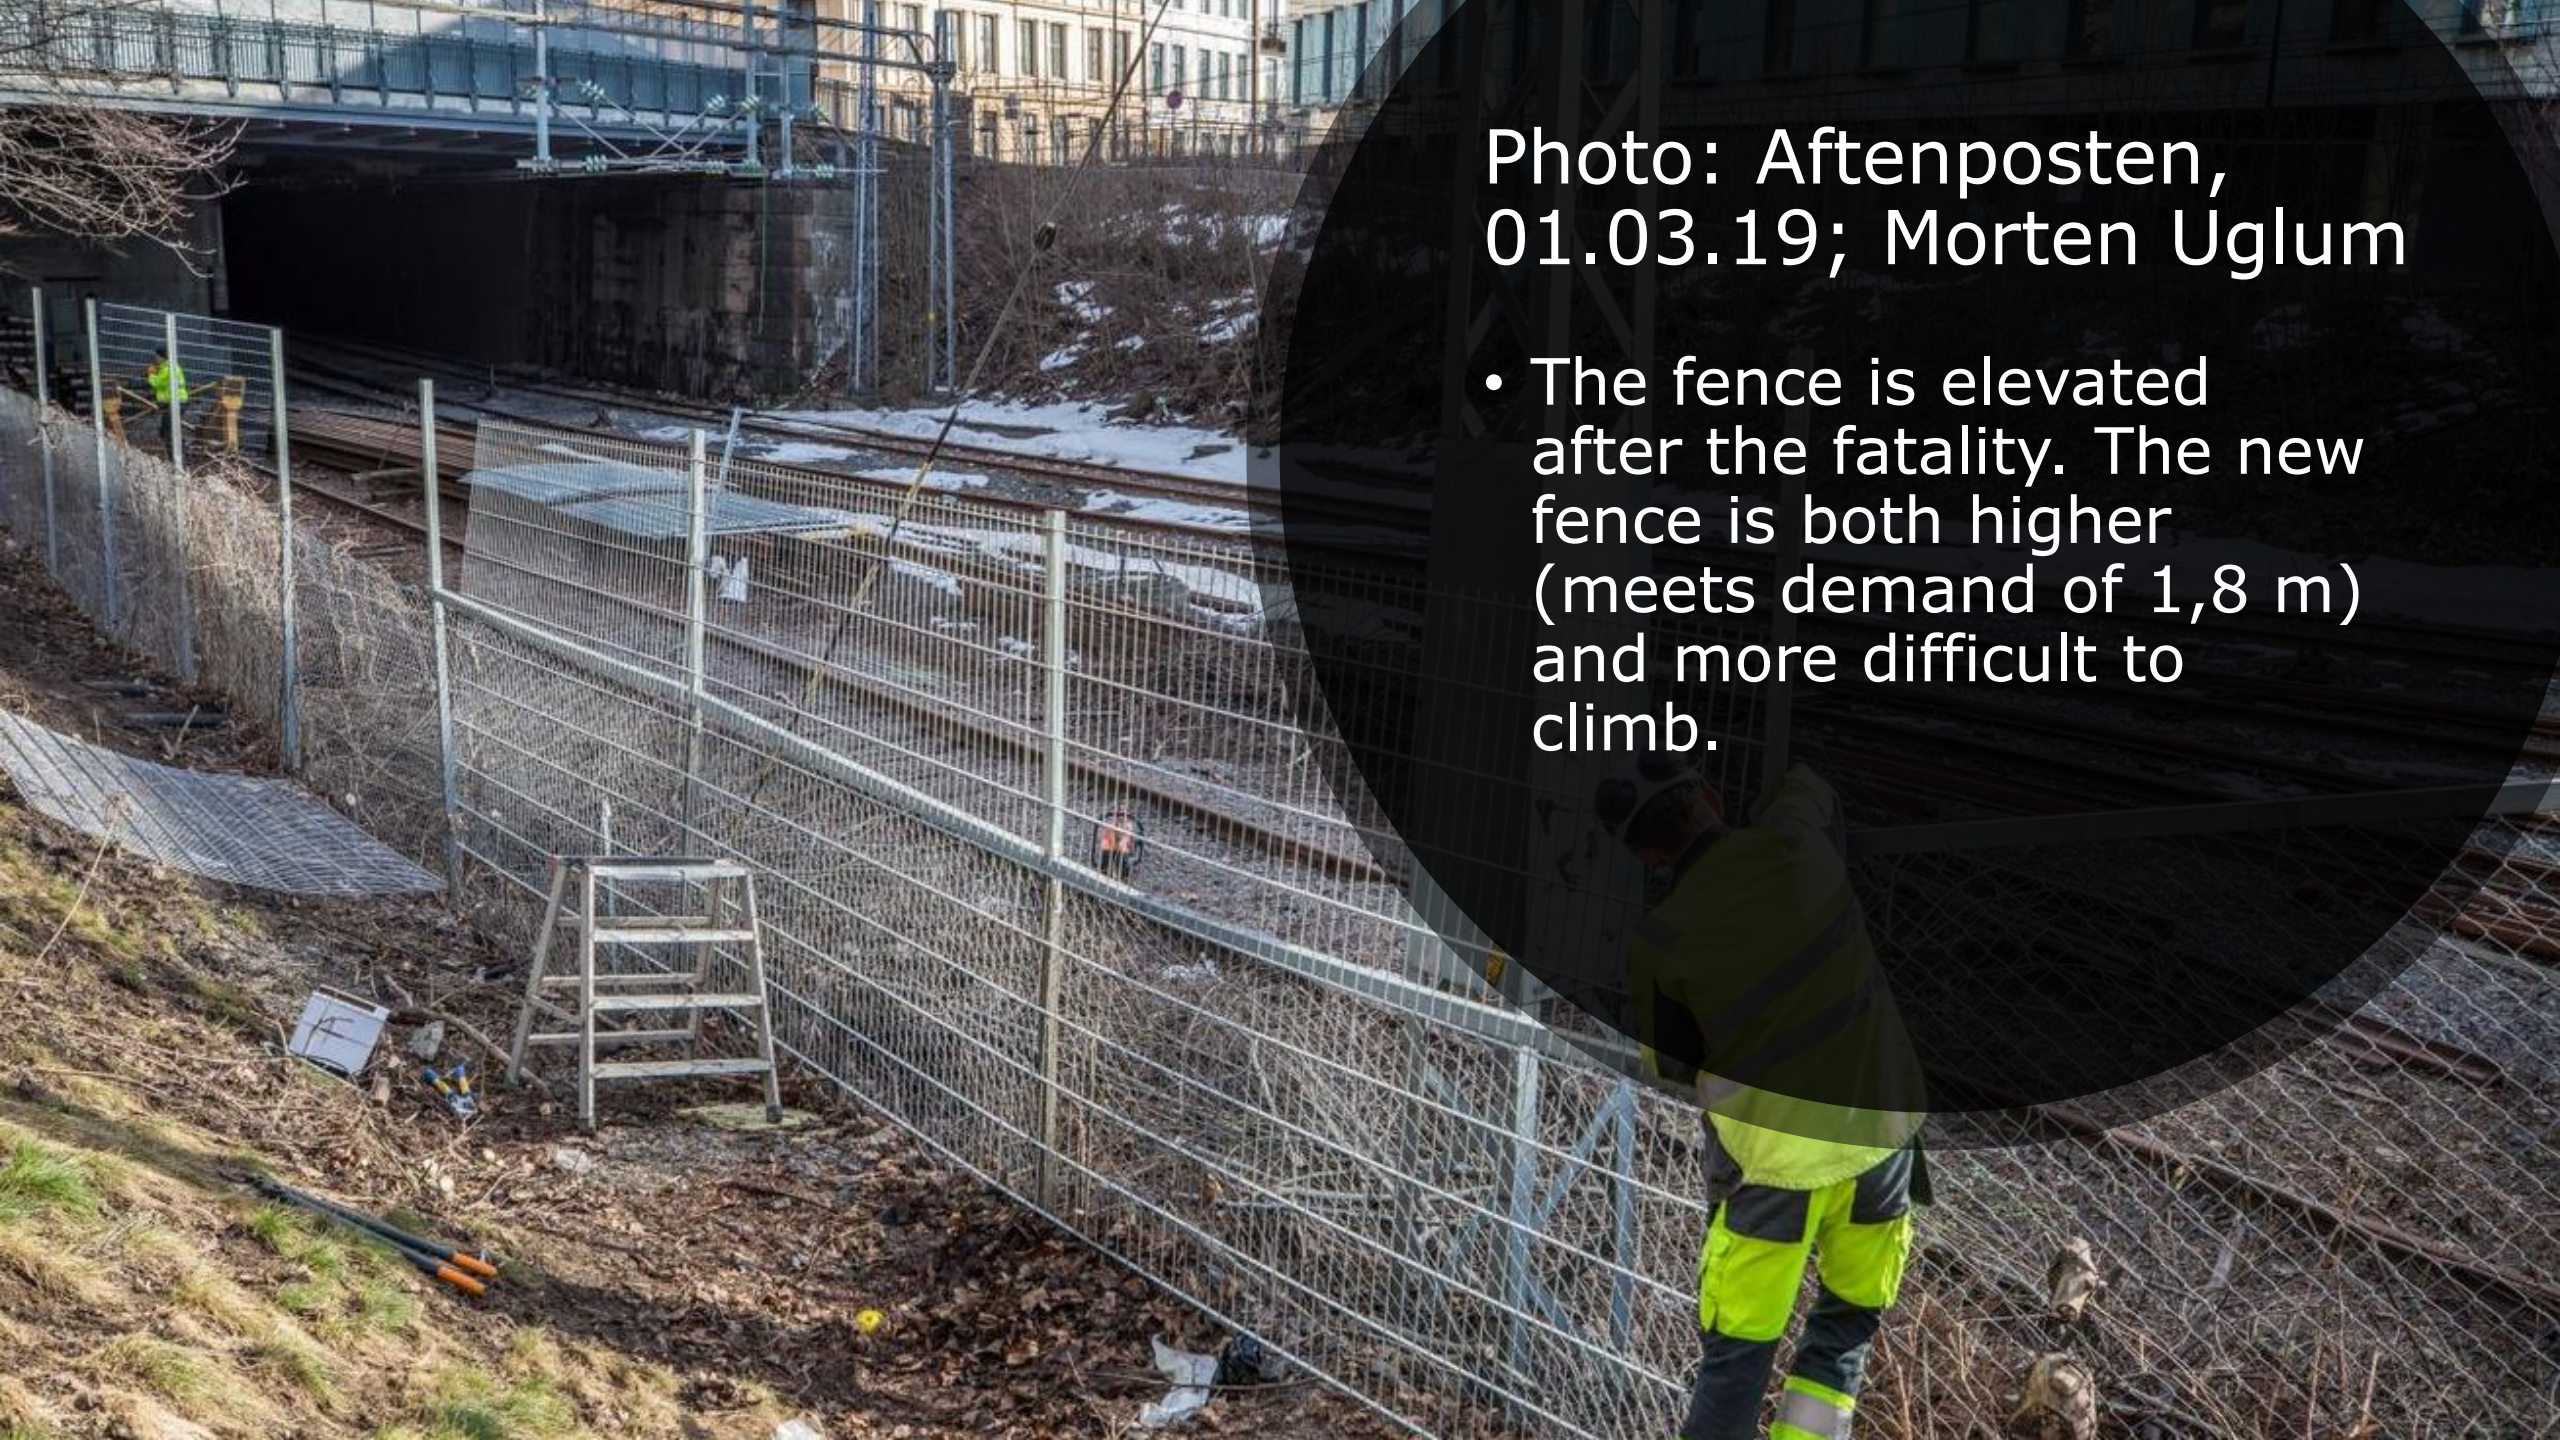
- The fence is elevated after the fatality. The new fence is both higher (meets demand of 1,8 m) and more difficult to climb.

- 15-year old pupil dies after passing the fence from the neighboring youth club to the left in the picture. The fence is only about 1 m of height

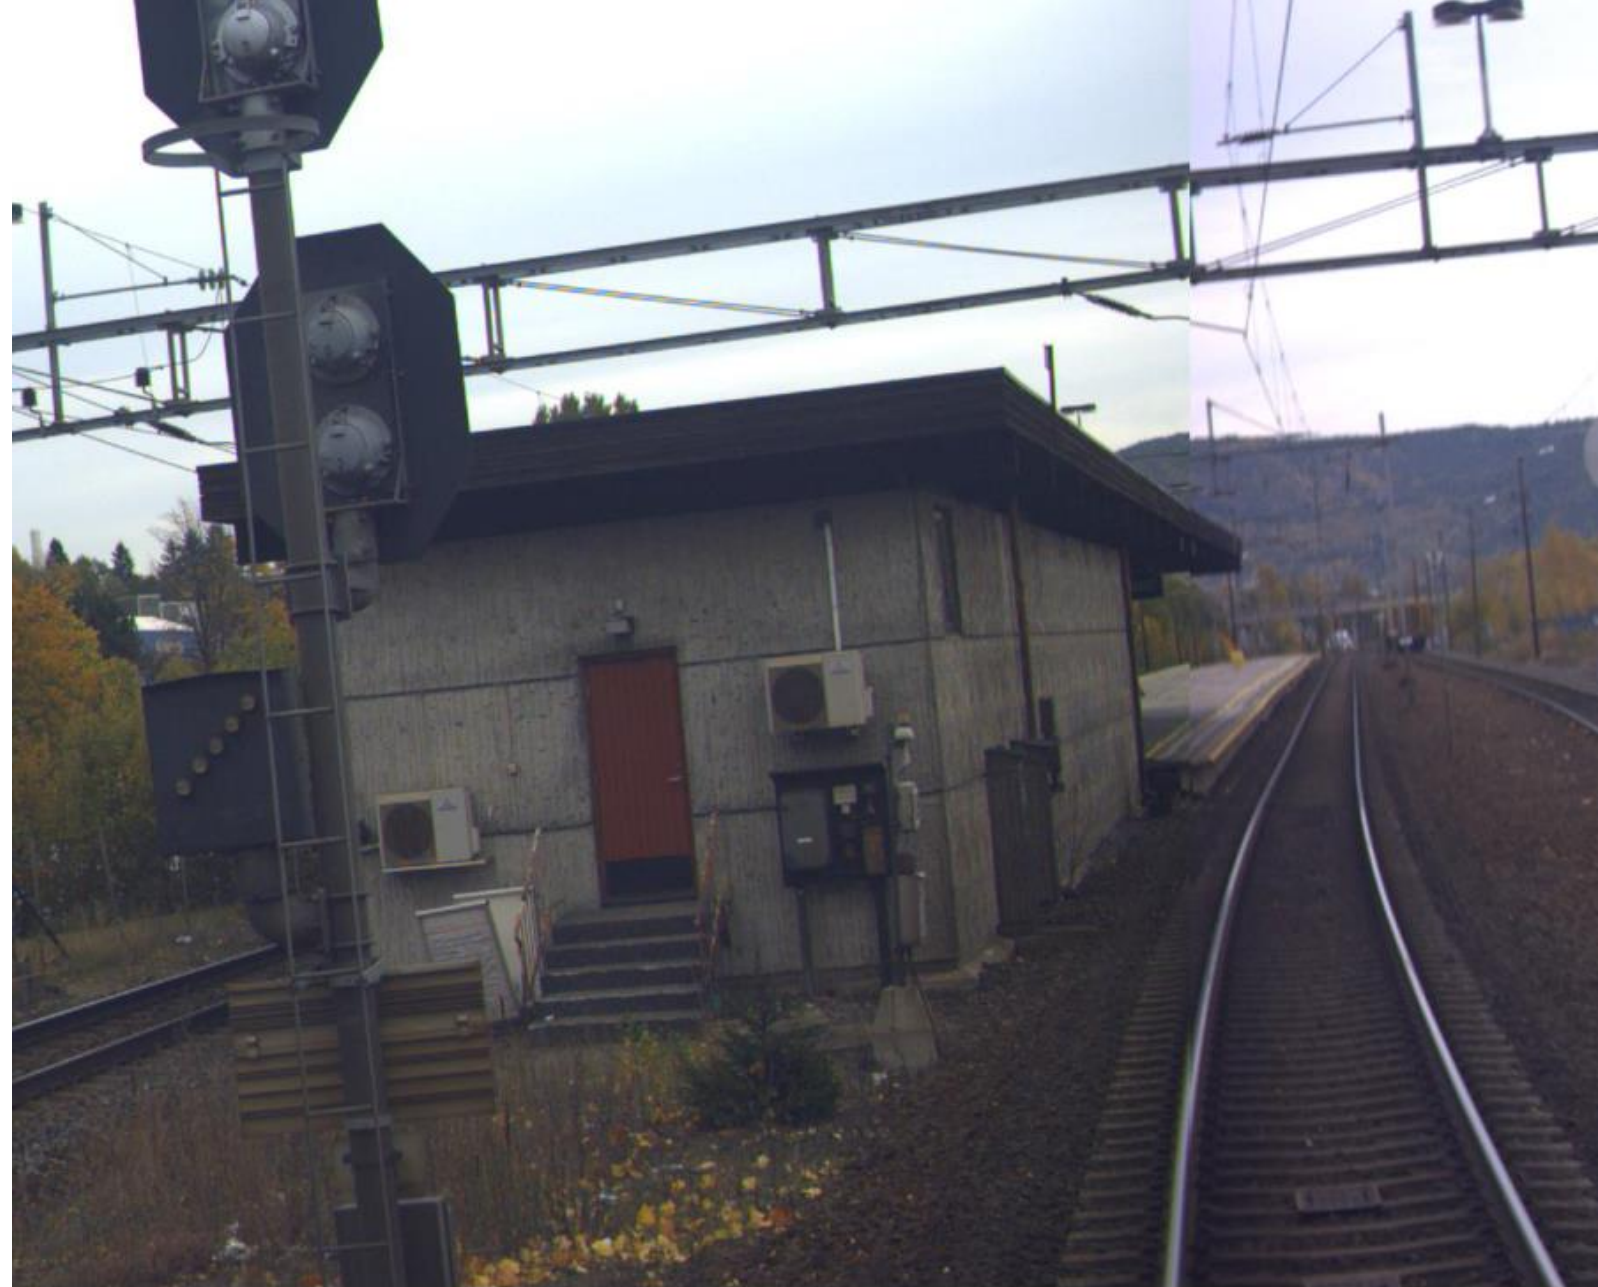
Brakerøya station

(2 accidental fatalities 2007-2016)

Screenshot; Bane NOR  
(Målevognsbilde)

Station:	Suicides	Accidental deaths	Comments:
Lillestrøm	5	0	Airport express train
Asker	4	0	2 in adjacent tunnells
Nationaltheatret (Oslo)	2	0	1 of 2 railway stations in Norway below surface
Kløfta	2	0	Trains passing at high speed
Blommenholm	2	0	Smaller station at lower-speed line
Vevelstad	2	0	Smaller station at lower-speed line
Brakerøya	0	2	Industrial surroundings, problem area
