"How are hotspots identified at the railway, and how should the IM cope with the variable levels of risks?"

UIC, Paris, 25.03.2019

Master  
thesis 2018,  
HSE, NTNU  
& Bane NOR

«Unwanted occurrences at the Norwegian railway where third persons are hit by Train».

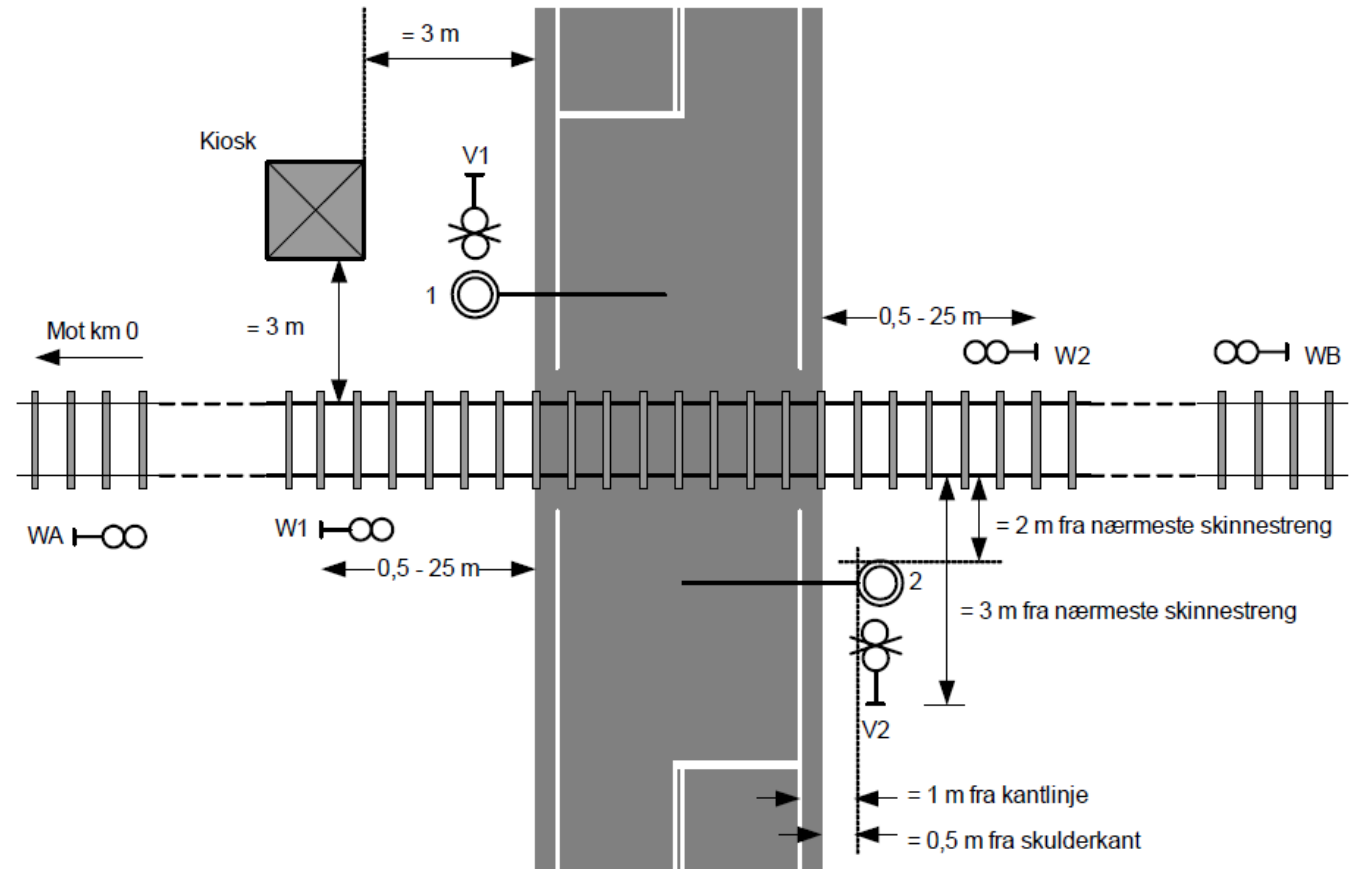
From the IMs  
technical  
legislation:  
No demands of  
sight length when  
the LC is secured.

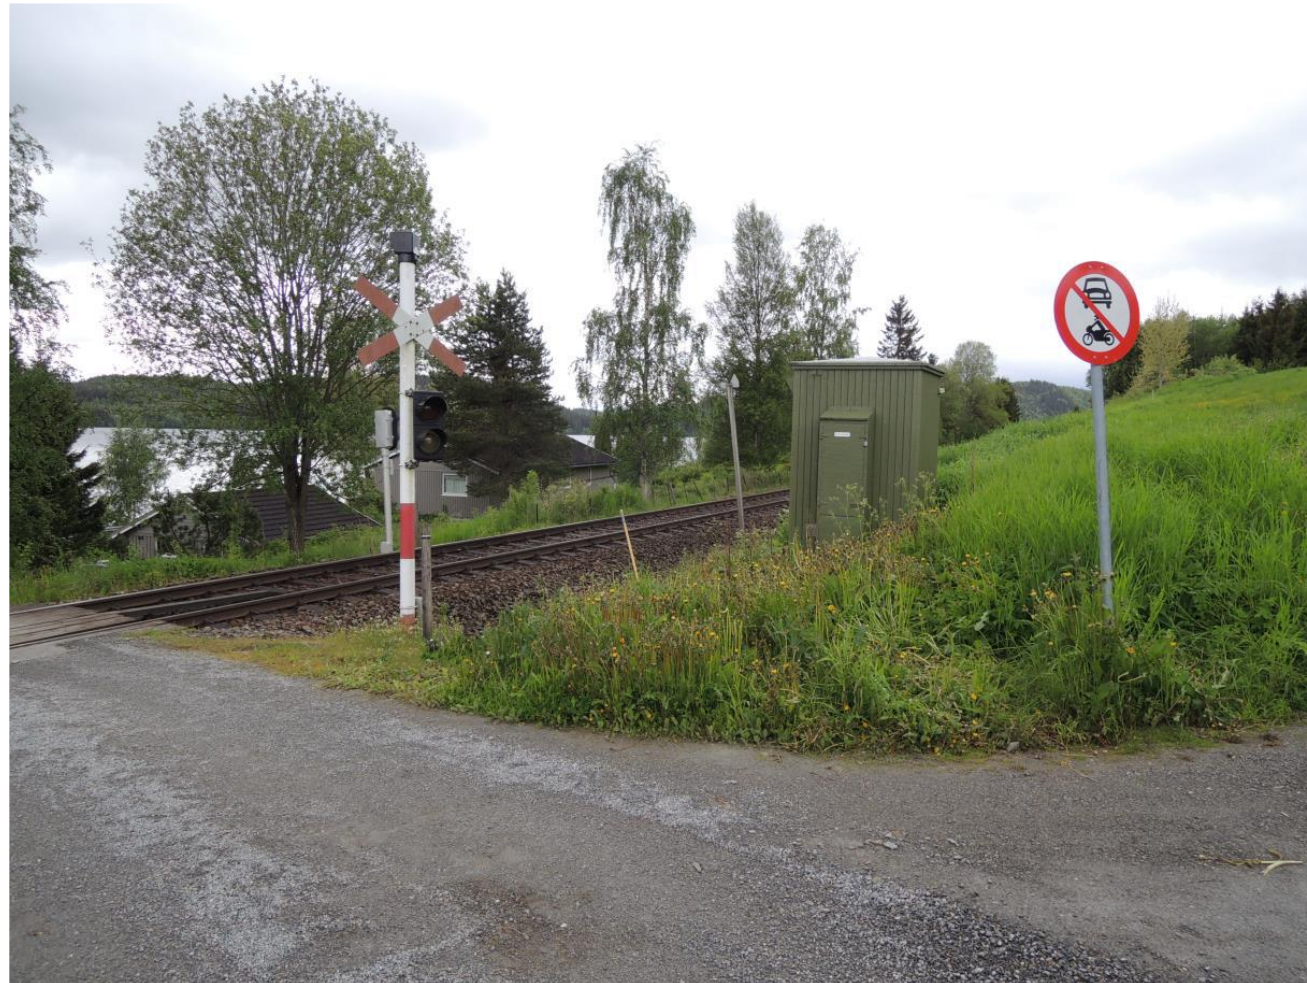
# Trapneset LC (Collision train/car 10.06.2015)

The car driver died,  
the LC was closed  
afterwards.

Sight? No demands  
of sight length  
when the LC is  
secured.
