REDUCTION OF SUICIDES AND TRESPASSES ON RAILWAY PROPERTY

WARNING SIGNS AND POSTERS

WHERE: The stopping place named “Valladolid-Universidad” located at the conventional gauge railway, L Madrid-Irún, PK-25+600, in Valladolid, Spain.

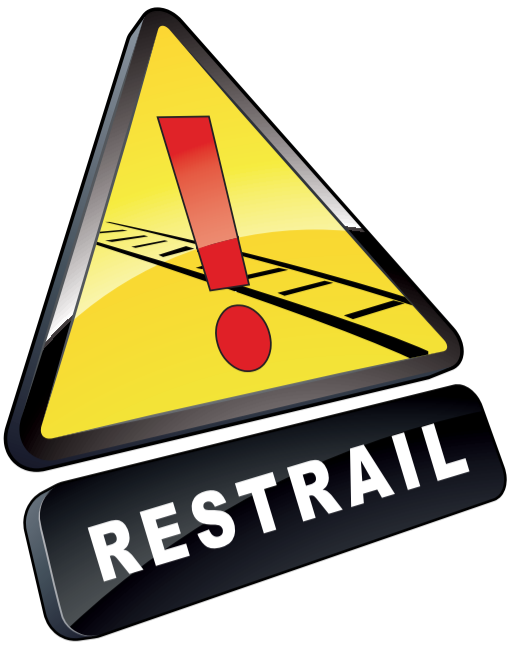
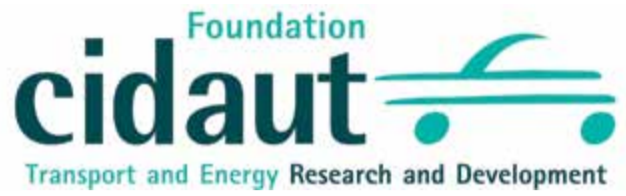
WHAT: The warning signs consist of a range of images and texts aiming to transmit information about punishments associated to cross illegally the rails, targeted at preventing trespasses in the railway property.
